# DEVIATION ANALYSIS CASE STUDY

Test Report: Polyga Compact C210

Polyga Compact C210

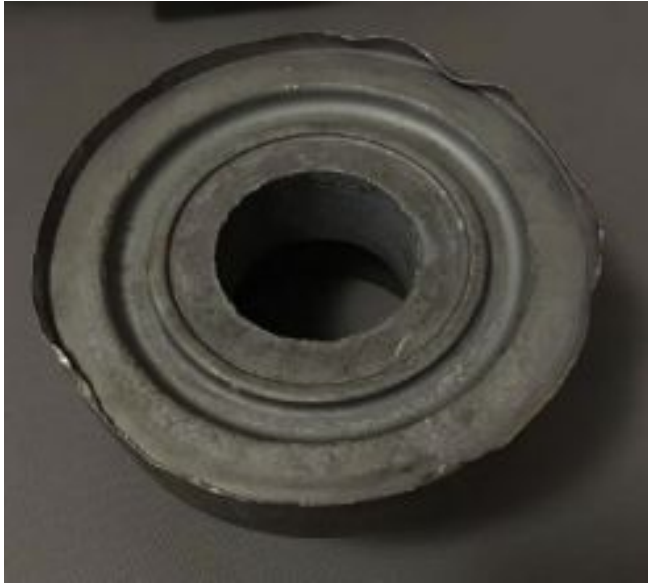
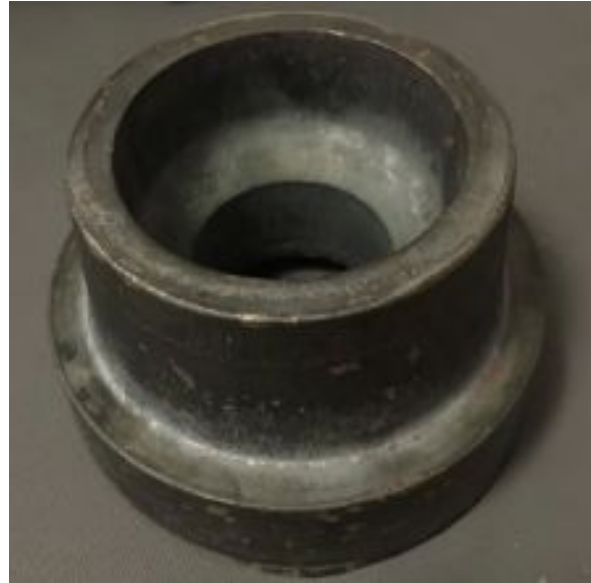
## Scan Results

The top part of the object can be scanned without using any reference objects due to its unique geometry along the edges. These unique edges were used to align the parts.

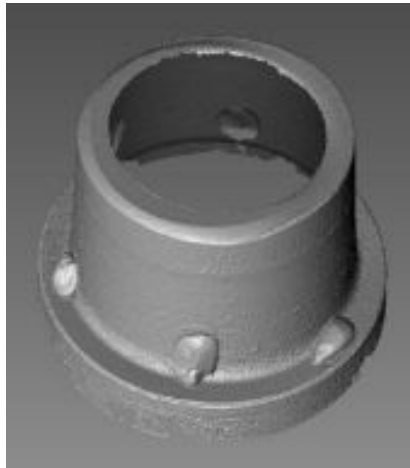
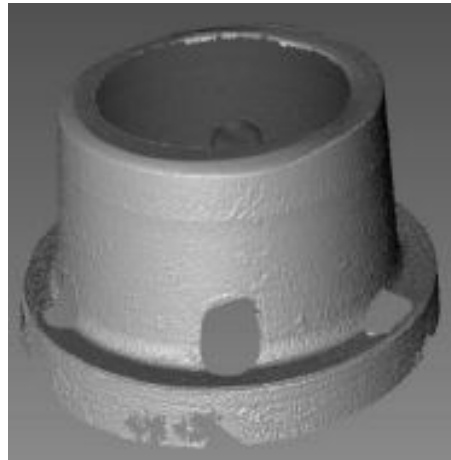
For the bottom, putty needs to be used in order to align the scans properly due to the geometry being symmetrical. Users can manually remove the reference objects from the scans within FlexScan. However, it will leave a hole on the scan.

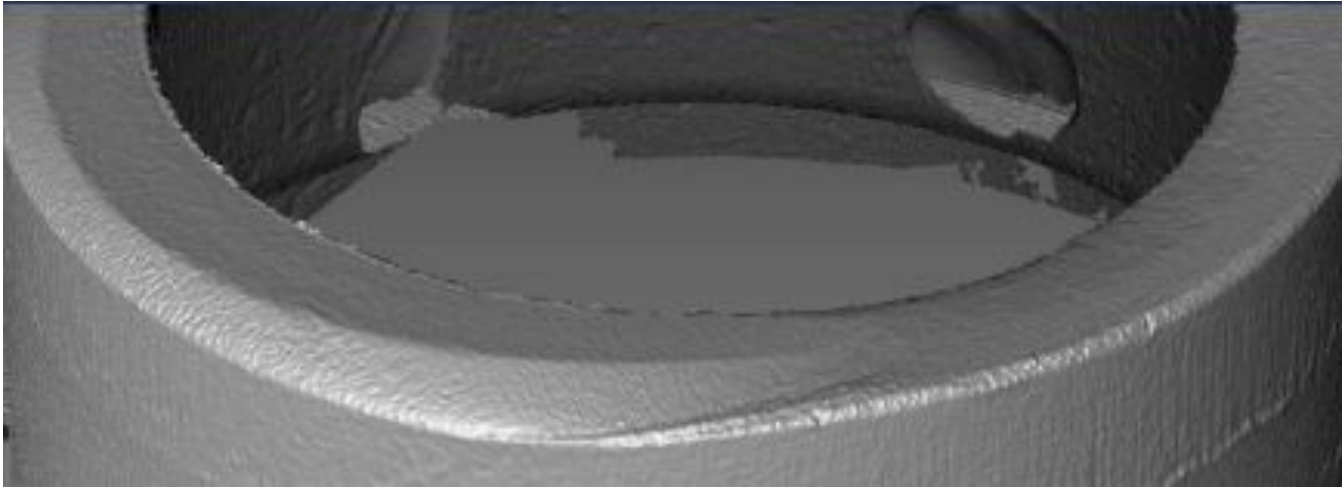
If users want a complete model without any holes, they will need to perform another scan without the reference objects and rely on the top edges on the bottom part to align the scans. Screenshot above shows the top edge is actually not symmetrical and could be used for alignment. Another option is to re-scan the part while placing the reference objects at different locations from the original. Users can then manually edit out all the reference objects and align the two complete scans and merge them together.

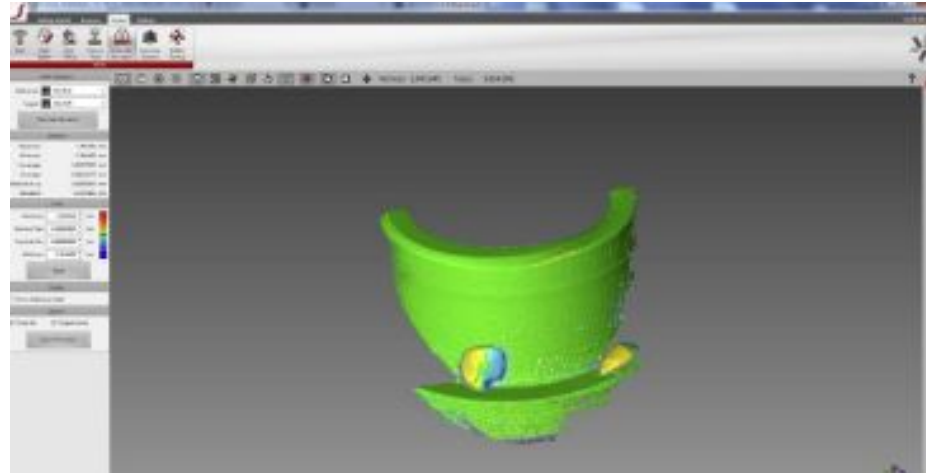
In order to compare scans, new scans should be taken to be used as the target to compare to the reference scan. Once the new scans are captured, users will need to manually align them to the reference scan before comparing. To compare the scans, navigate to the "Calculate Deviation" mode and select the "reference" and the "target" then click on "Calculate".

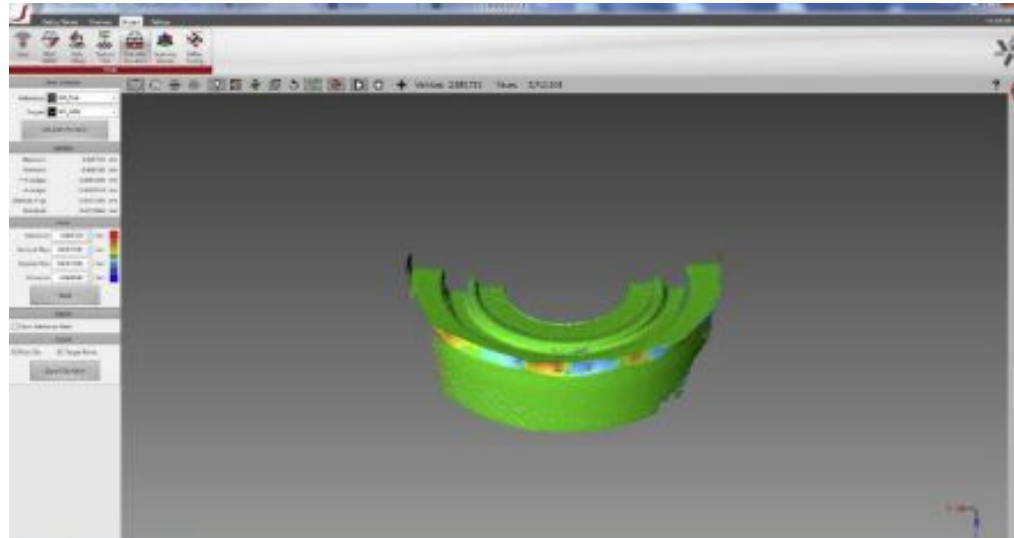
Note that only one scan can be compared at a time. Therefore to compare three scans, it may take slightly longer.
